GREEN AUDIT REPORT

GITAM UNIVERSITY

Nagadinahalli, Bengaluru

Conserve Consultants Pvt. Ltd.,

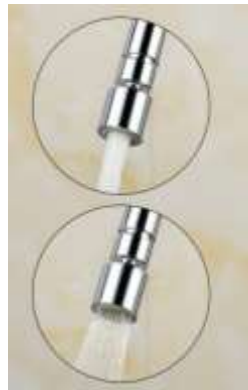
a. Low flow aerators.

To reduce the fresh water consumption by installing the aerators for faucets in all guest rooms, common area restrooms, kitchen etc., this reduces the 40% of water consumption from the baseline of LEED.

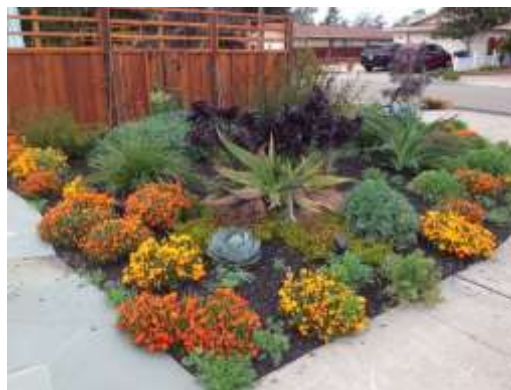
c. Native Plant Species.

For landscape STP treated water is used for irrigation. In landscape so many non-native species like cynodon dactylon (Grass) is high water consumption. To reduce the water consumption by replacing the drought tolerant/xeriscape species.

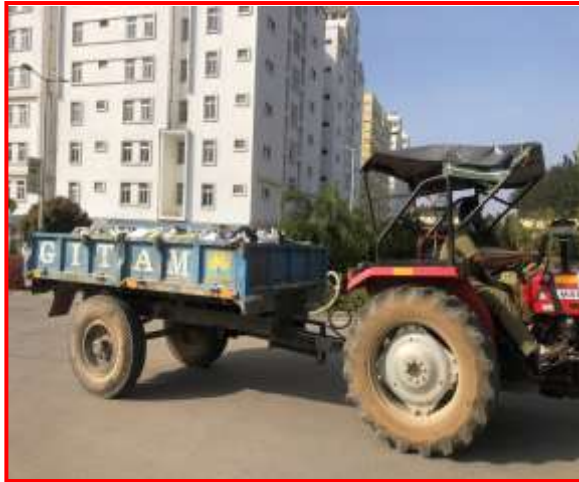
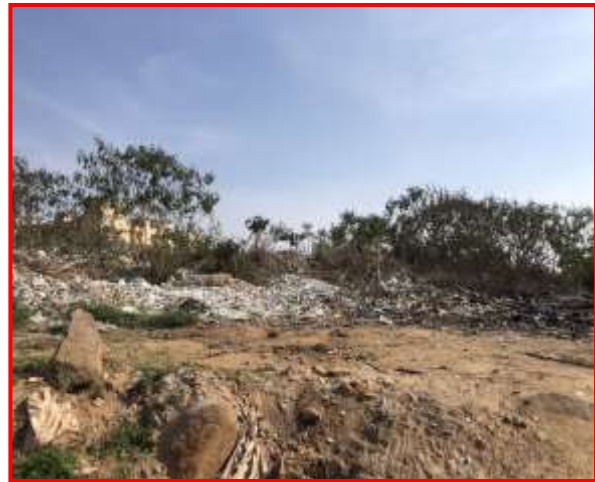
Report No.	C&A/SOR/05	Date	10.02.2022
Location	Outside of the Campus

Centralized dust bins are not provided for the collection of whole campus waste.

Except food waste all the solid wastes are sent to municipal landfilling (outside of the University Campus) by the Tractor. It is recommended to send the waste to recyclers to reduce landfill dump yard/avoid incineration. 1. Multiple type waste bins (paper/glass/metal/plastic/e-waste) shall be kept in many places to facilitate the segregation wastes at the sources itself and then 2. Centralized waste collection area for multiple waste types so that wastes can be accumulated for period of time, which in turn will make the waste recycling economically feasible for the recycling vendors.

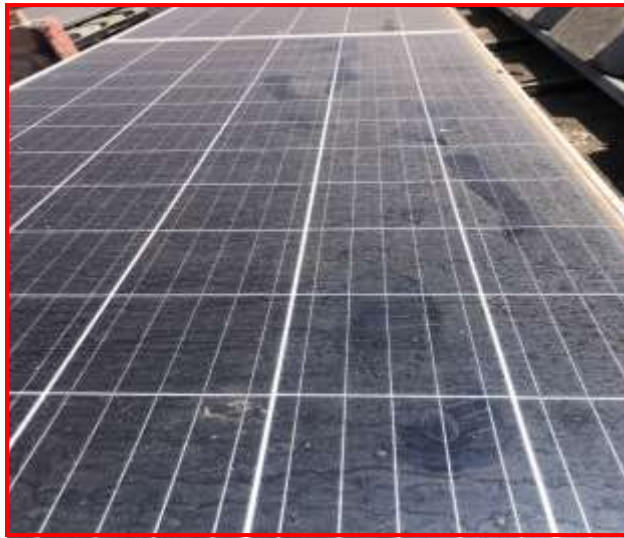
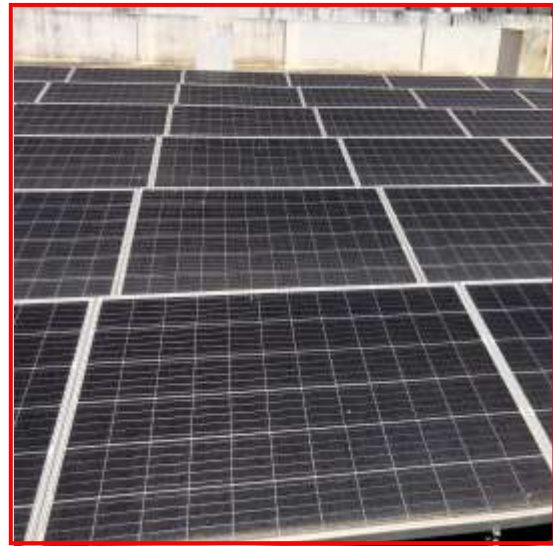
Report No.	C&A/SOR/07	Date	10.02.2022
Location	Admin 1 & 2 Blocks, Staff Quarters Roof Top (498 kW Solar PV Panels)

Dusts on Solar PV panels were observed.

It is highly recommended to clean the Solar PV Panel at manufacturer recommended intervals better power generation efficiency.

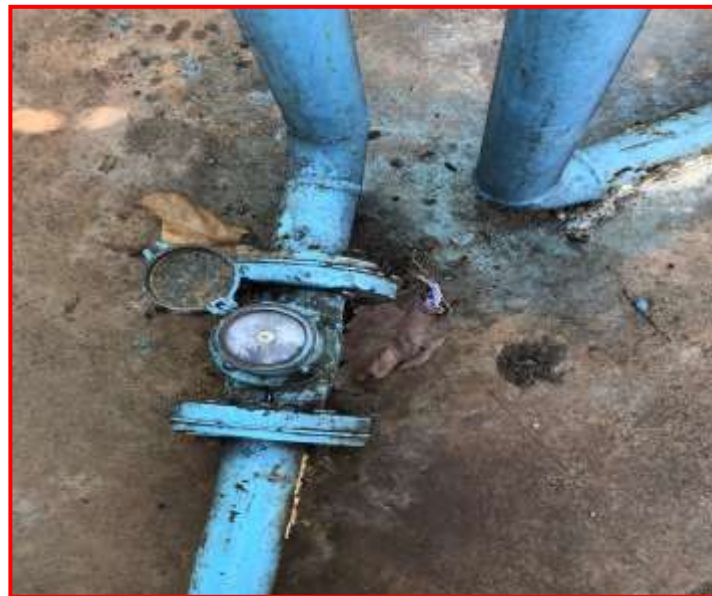
Report No.	C&A/SOR/08	Date	10.02.2022
Location	STP Plant

Installed water meter for STP Plant is not working. STP Water is used for Gardening.

It is advised to install new digital water flow meter for regularly monitoring the STP water consumption as well the STP performance.

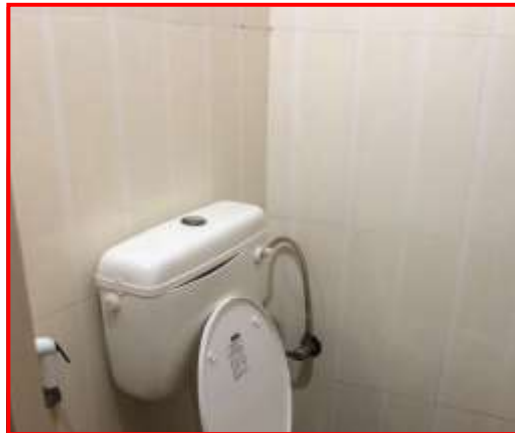
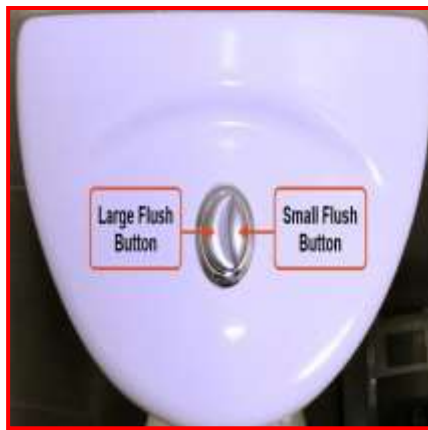
Report No.	C&A/SOR/10	Date	10.02.2022
Location	Admin Blocks, Boys & Girls Hostels - Rest Rooms

It is observed that western toilets are not with dual type Flush.

It is advised to install dual type flush, which reduce the water consumption. Reduction in water consumptions also leads to power saving, it saves the operating duration of the water pumps directly. And it is appreciated that metal taps in the bath rooms are installed with Aerators.

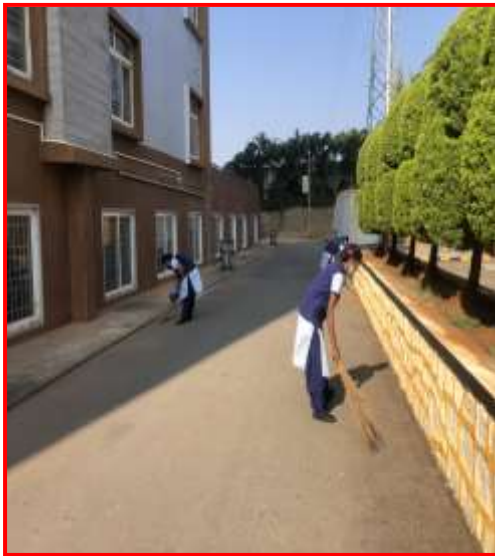
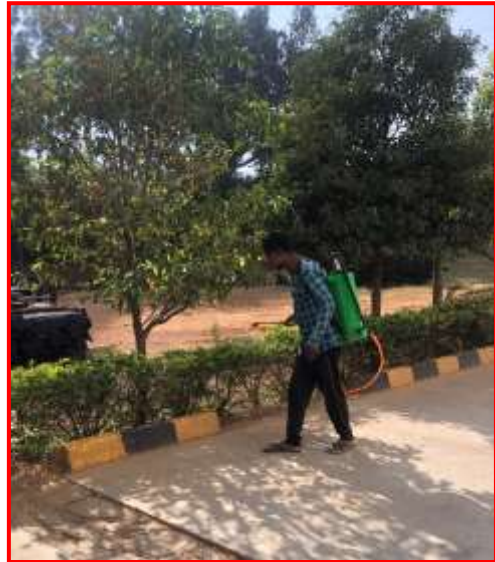
Report No.	C&A/SOR/14	Date	10.02.2022
Location	Pathways and Garden Area

Regular cleaning inside the campus pathways and gardening area.

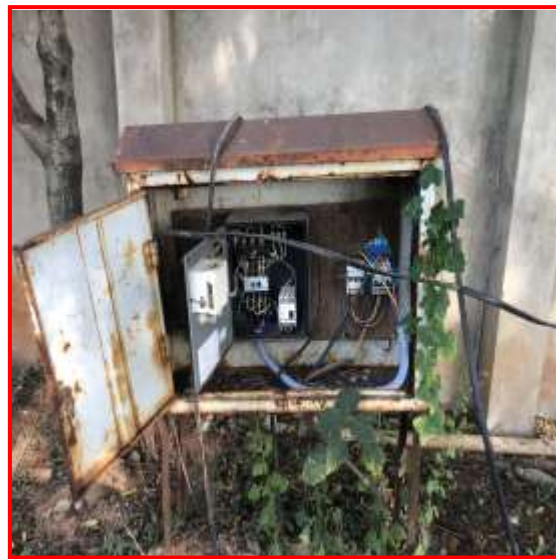
Report No.	C&A/SOR/15	Date	10.02.2022
Location	Outside the Campus near Labour shed & New Hostel

Bore well pump motor is not working and it is malfunctioning. Panel maintenance can be improved.

Replace the old pump motor with new efficient IE4/5 motor. And maintenance of the panels shall be done regularly as per the preventive maintenance schedule.

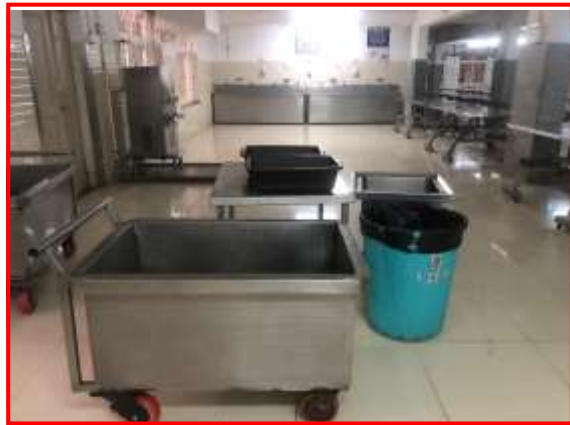
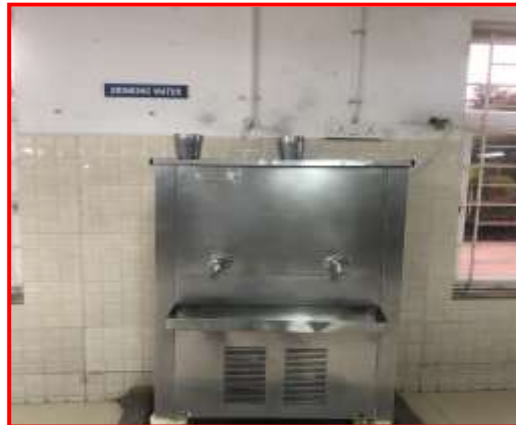
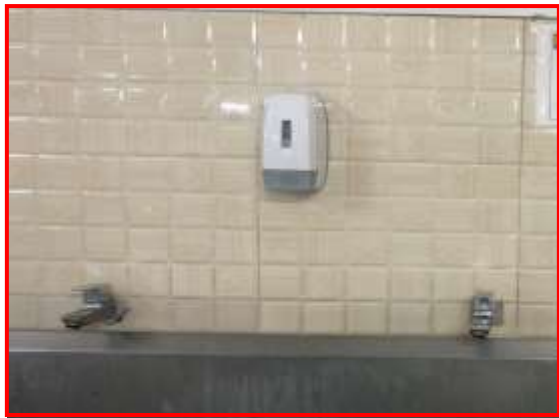
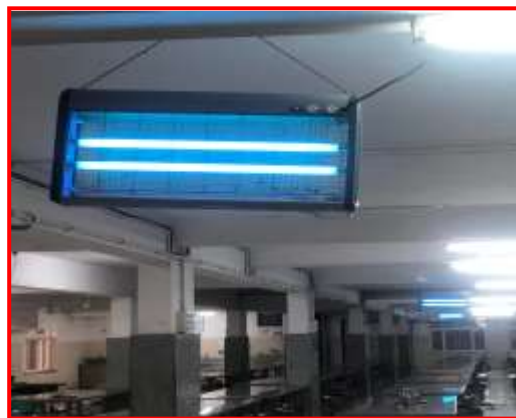
Report No.	C&A/SOR/17	Date	10.02.2022
Location	Canteen

In the canteen area, Pest O Flash (Flying insect electric control system) are installed, Hand washer at Wash basins and Drinking Water slogan pasted near Drinking Water Area. It is highly encouraged. But Food waste slogan label is not pasted in the Food waste Bin.

It is recommended to Paste the Food Waste slogan in the Food waste Bin. So it will easy to segregate from the different source of Wastes. Also paste the Waste slogan wherever necessary.

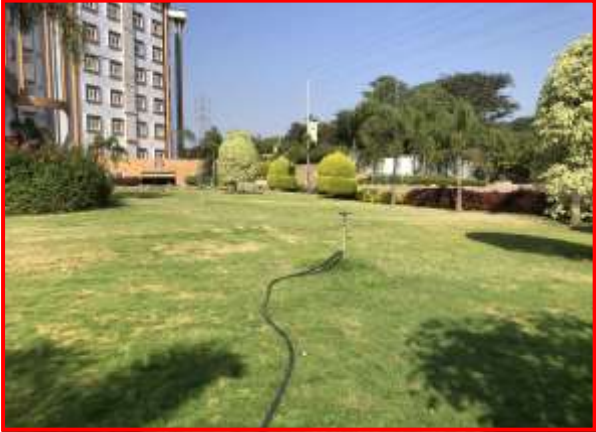
Description			
In maximum area, landscape is being done as grass, which has higher water demand.			
Potential Sustainability Measures			
This type of grass shall be replaced with Druva grass or other native species of xeriscape plants. Also a mix native shrubs shall be planned at various spots.

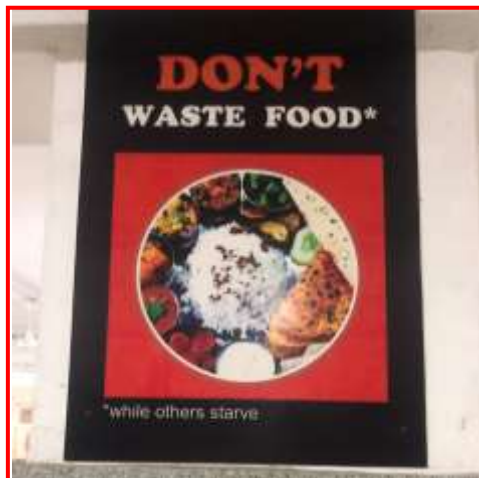
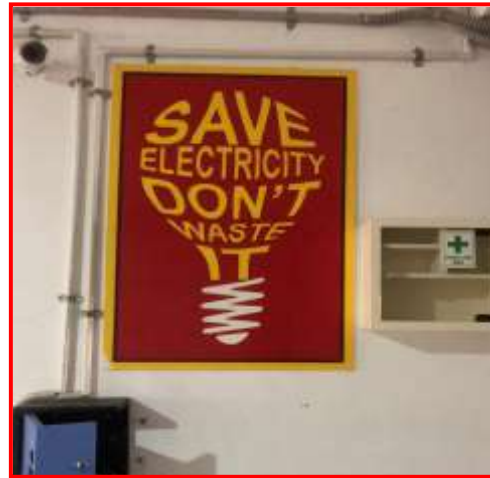
Report No.	C&A/SOR/19	Date	10.02.2022
Location	Canteen & Hostels

There are different posters for Energy, Water and Food Conservation and they are displayed in the respected Areas.

It is highly encouraged. This type of practice need to be followed in the University Campus, which creates awareness to future generations about savings of energy, water and food, the natural resources.

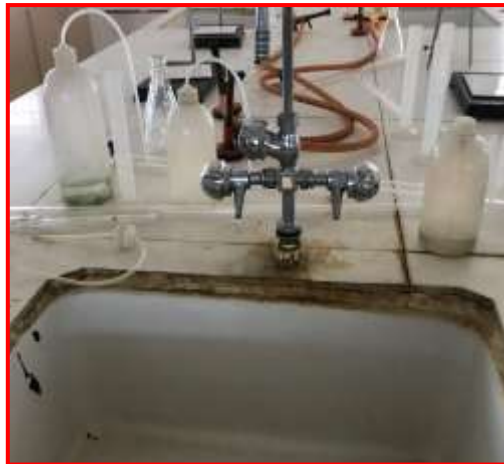
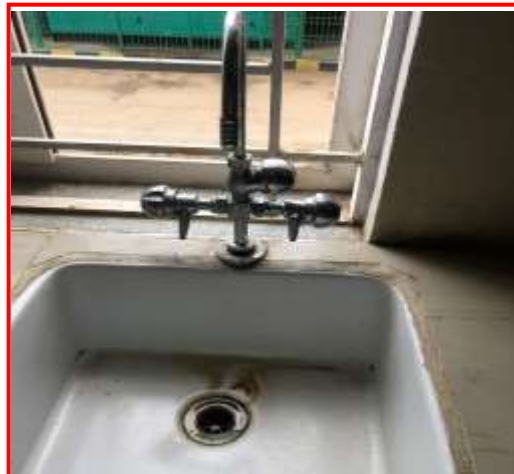
Report No.	C&A/SOR/20	Date	10.02.2022
Location	In Chemistry Laboratory

It is observed that water is leaking in water taps in Chemistry laboratory.

It is recommended to replace any leaking water taps immediately along with aerators retrofit, which not only controls the flow and but also conserves water.

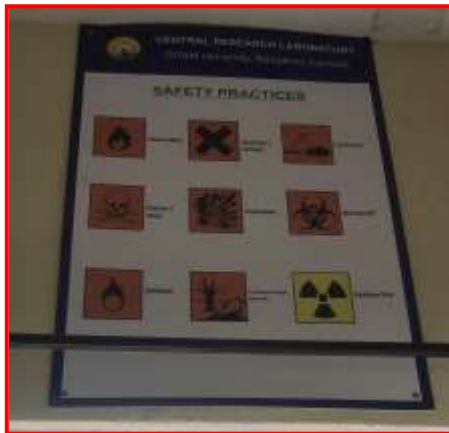
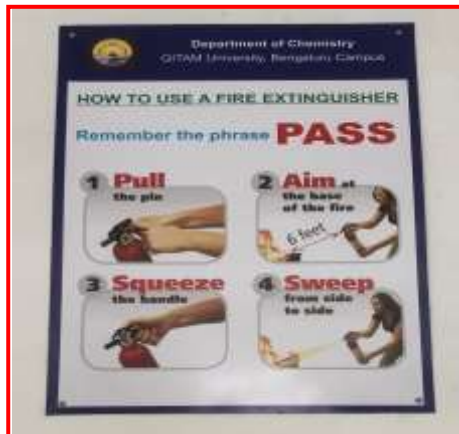
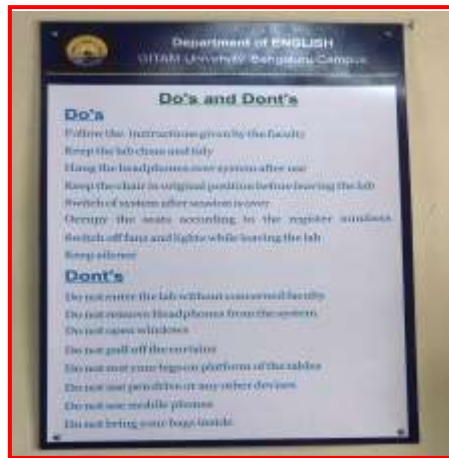
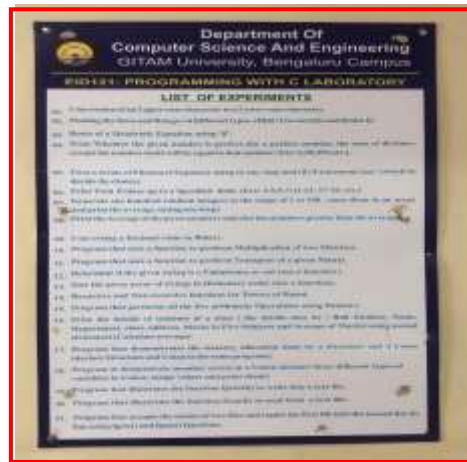
Report No.	C&A/SOR/21	Date	10.02.2022
Location	In all the Laboratories

It is observed that in all the Laboratories Safety Practices, How to use Fire Extinguisher, Do's and Don't's, List of Experiments banners are displayed on the wall.

It is highly encouraged practices in the Laboratories, which creates awareness and safety measures on how to handle the experiments among the students.
